CanSat 2017 Post Flight Review (PFR)

**Team 5851
IQRASAT
Yildiz Technical University**

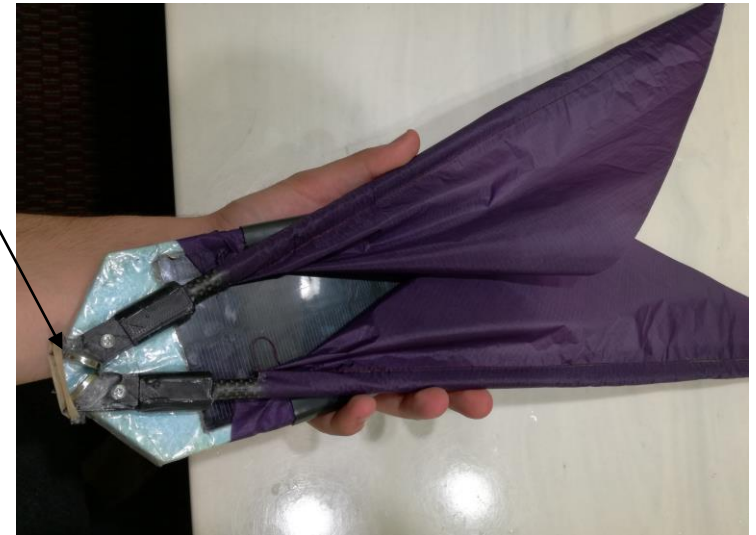
Rubber band and magnets
